Azerbaijan Alternative Energy and Energy Efficiency Project Development Support

Report to LEAD International and Hayat NNGO

Steven Hunt
20th June 2006

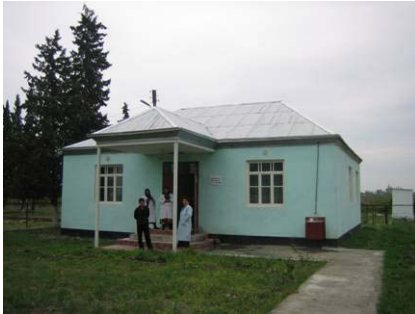
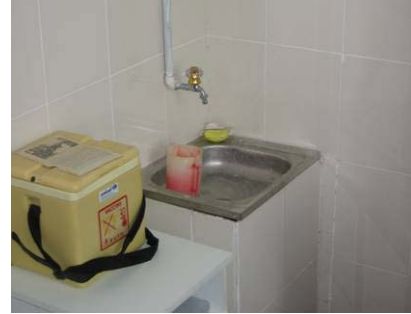
The Qara Jali Community Medical Centre was built in April 2005 with International Medical Corp and BTC financing. It provides general medical, dental and midwifery services to around 450 community members of two local villages at a rate of around 5-10 persons per day. The centre has a total staff of 15 although typically about 3-4 are present at any one time. The staff live locally and typically occupy the building from around 7.45am to 4 or 5 pm in the evening.

The building as it stands is in fairly good condition as would be expected of a new building, but does not incorporate any energy efficiency measures and is lacking several key services. The following main problems were explained by Dr Matanad Gurbanova who runs the centre:

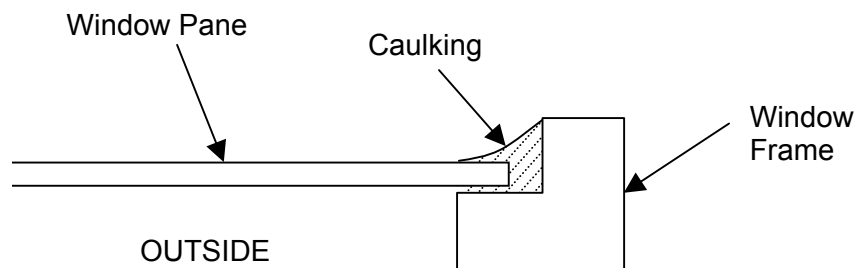
Figure 2 - Caulking Application on single glazed window

The most appropriate type of caulking which is readily available locally is silicone caulking which comes in tubes using a gun type applicator. The type of seal which may be obtained is as shown in cross section in Figure 2 below.

Although the most energy efficient solution would come from replacing the windows with double glazing, given the newness of the windows and good condition of the frames, it is recommended that instead particularly poorly fitting panes be replaced and caulking applied to the edges of all window panes to ensure a seal with the frame. This will significantly improve the performance of the windows in resisting heat loss at a fraction of the price of replacing the windows. This will also highlight a simple practice in improving building air tightness to community members visiting the clinic who may also not have the capital to afford full double glazing.

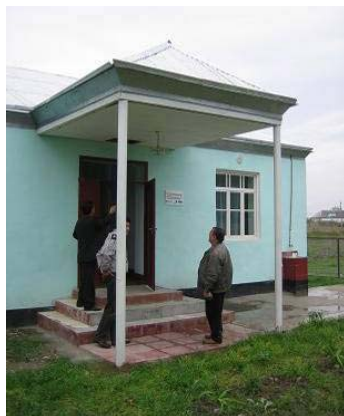
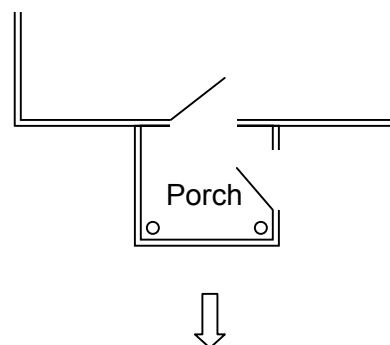
Figure 3 – Existing covered area and diagram of possible added vestibule wall

The frequently opened front door is a big source of heat loss, particularly when it is north facing as in this case. The first step would be to insulate and seal it as described above however it would also be very beneficial to shield this door from the north wind and provide a buffer against opening directly to the cold air. The most effective way to do this would be by creating a porch vestibule in front of the clinic, filling in the walls under the existing roof section as shown in Figure 3 below:

Filling in the walls of the porch would provide a buffer space “air-lock” so heat in the building would not be lost as the front door is opened into the protected space. Placing the door to the porch on the west side of the porch (where the path currently runs up to the main door anyway) would deflect the worst effects of the cold northerly winds.

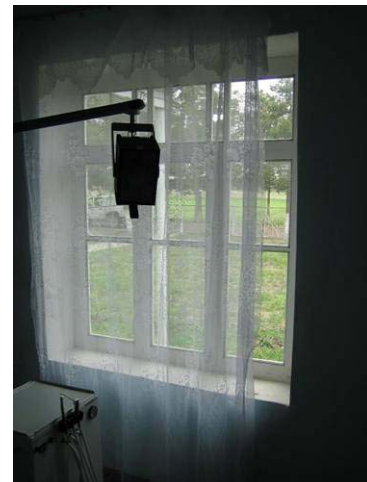
Figure 4 - Curtains and window in the Qara Jali Clinic

The curtains currently provided in the clinic are thin net type curtains as shown in Figure 4. These allow through a lot of light but do not provide any thermal barrier to the heat lost through the windows. If these were replaced by thicker curtains this would provide a valuable, low cost and flexible barrier against heat loss. The effectiveness however of the curtains however would need to be balanced with the proportion of the time with electricity is available since clearly if no light is available thicker curtains would not be useful.

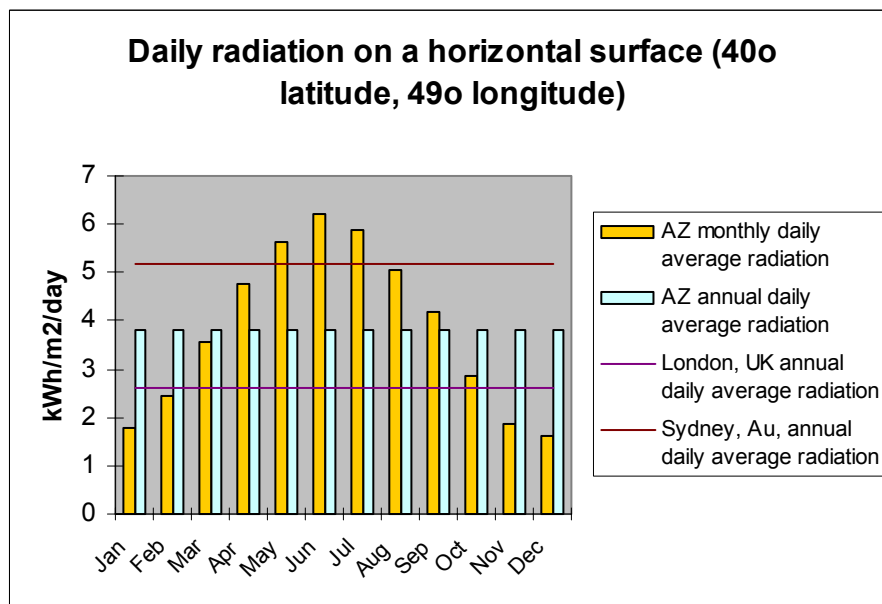
Figure 5 - Average expected solar radiation in Azerbaijan⁴

As can be seen from the graph above, the average radiation levels expected in Azerbaijan on the basis of latitude and longitude compare very favourably with Northern European countries like the UK which have a large number of solar installations, although it is below high insolation countries like Australia. At the time of writing, Hayat staff are attempting to source local weather data for Qara Jali (or at least Ujar region) to provide further information about particular local weather conditions including solar radiation. This information will be very important in understanding the storage and

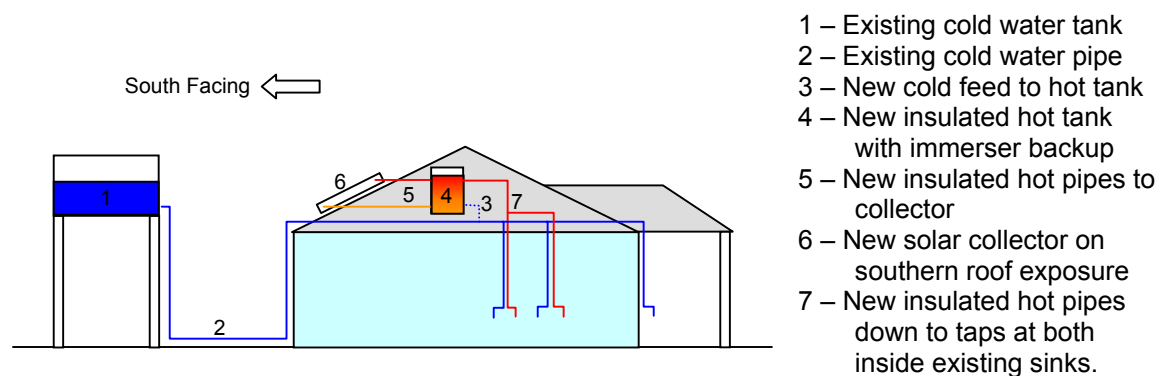
Figure 6 - General layout of clinic solar water heating system

Figure 6 shows a direct solar water heating layout with circulation of the water driven passively by the thermosyphon effect of hot water rising. A direct system is the simplest and lowest cost type of system available however the supplier will have to warrant the design for the specific weather conditions at the site since in extremely low temperatures freezing and damage can occur in the solar collector at night. A thermosyphon based system is also simpler and lower cost than a pumped circulation system but can be

slower in acting and the supplier may recommend a small pump which may be powered from the solar PV panel (see next bullet). Additional design features can include expansion chambers for extremely hot days when the water can boil, and water level float valves to control the cold feed. If, as recommended an electric immersion heater is added as back up, it should only come on as needed and so a temperature sensor and switch would be required. Suppliers of solar water heating systems exist in Azerbaijan and discussions are underway between Hayat staff and Gunas Istisi who provide a range of sizes, prices and capacities of system although the requirement here will be at the low end of the size and cost range.

The existing cold water pipe (2) would have to be repaired at the joint just under the valve on the downpipe from the cold water tank. It is advisable also to lag the existing cold water pipes to avoid a repeat of the frost damage seen currently. The new insulated hot water tank (4) would be installed in the roof cavity of the medical centre, gravity fed from a branch (3) off the pipe from the cold tank (1) which sits slightly higher than the ceiling level. Short insulated pipes (5) would carry the water to the solar collector on the south facing roof. The solar collector consists of high thermal conductivity black metal pipes on an insulated base under a glass screen which rise to a high temperature even under moderate sunlight conditions. New, insulated pipes (7) would then feed from the hot tank down to taps at both the internal sinks in parallel with the existing cold supply.

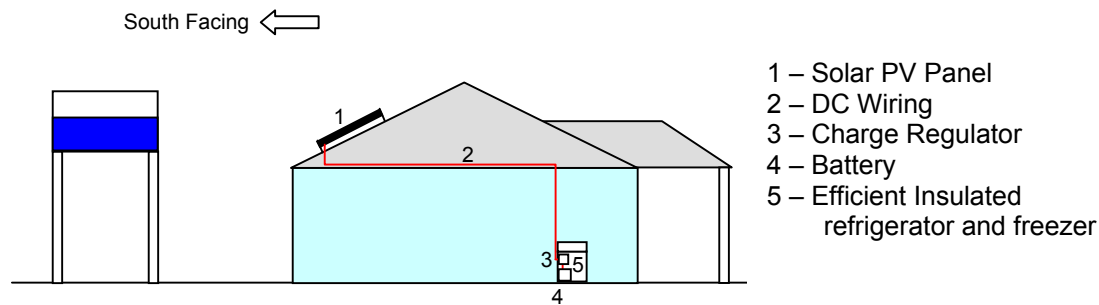
Figure 7 – General Layout of clinic Solar PV Vaccine Refrigeration System

Refrigeration is a particularly good application for solar PV as the system has inherent storage and the greatest need for refrigeration (hot summer afternoons) coincides with the greatest incidence of sunlight. In the clinic therefore, use of solar PV will ensure that even at the height of summer in the afternoon when no mains power is available, the solar PV will be generating to ensure that the vaccines stay within the specified temperatures. Solar PV vaccine refrigerators have no running costs and maintenance requirements are limited to battery changing (after around 5 years).

In the Qara Jali clinic the solar PV panel should be positioned on the south facing roof alongside, but not overshadowing or overshadowed by, the solar water heating collector described in the previous section. The specification of the refrigerator will be proposed by tendering companies and dependent on the local weather conditions, however given the community and building size, the refrigerator is likely to be at the smaller end of the range of system sizes, capacities and costs available.⁶

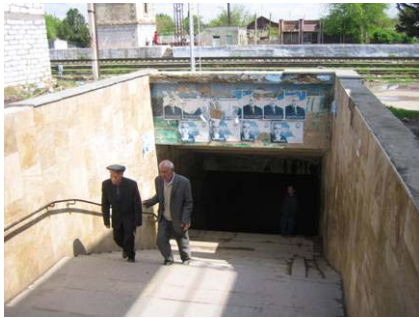
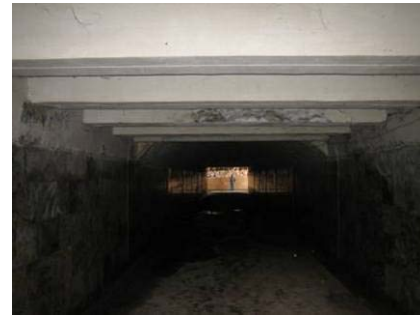
The Tovuz City Pedestrian Railway Underpass was built 25-30 years ago during the Soviet period in Azerbaijan. The underpass links the communities either side of the railway line which was built in 1883, as well as being the main route from the railway station to the amenities and public buildings around about the main square. Prior to the building of the underpass there were a number of fatalities on the line but since its construction there have been none reported. However, although quite grand when opened with many lights, ornate signs and marble cladding, the underpass has fallen into an extreme state of disrepair in the post-soviet era.

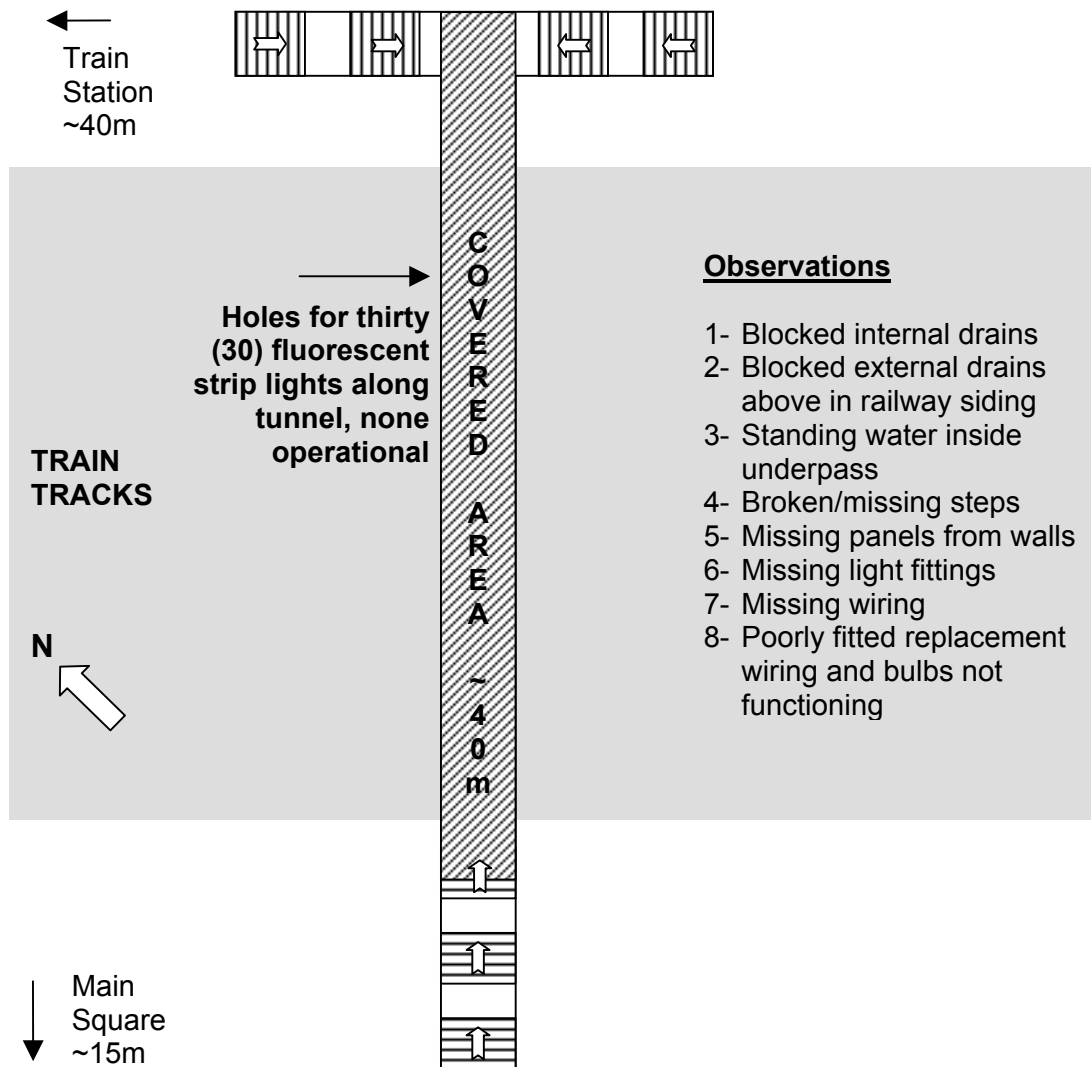
Figure 8 - Tovuz Railway Pedestrian Underpass Layout

At the time of writing Hayat staff are attempting to obtain an architectural drawing of the underpass from the transport ministry. The general layout of the underpass is as shown in Figure 8 below along with the main problems observed there:

The covered area of the underpass is approximately 40m long and even in broad daylight is very dark as shown in the right and left hand pictures at the beginning of this section. At night it is not possible to see your hand in front of your face within the underpass. In both circumstances, in addition to the fear of assault or robbery, it is not possible to see and avoid the many pools of standing water and urine evidenced by the smell in the underpass. Only young men were seen to use the underpass after dark while all other community members were clambering over the railway tracks through wet mud as the trains were passing.

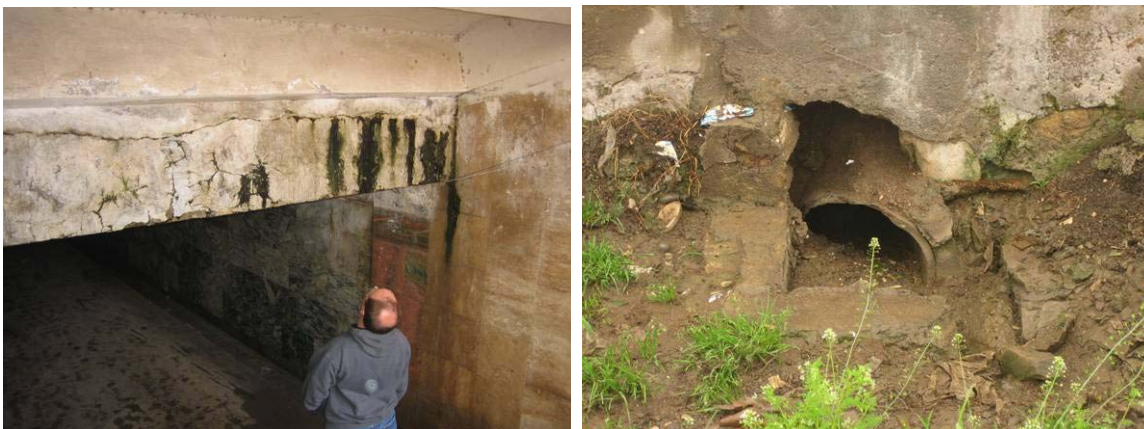
Figure 9 - Seepage inside southern end of underpass and blocked drain in railway siding above

Figure 9 below shows the water seeping from above into the underpass at the southern end, promoting algae growth and potential damage to the structure of the underpass (left) with a blocked drain in the railway siding directly above (right) which is very likely to be a contributor to the problem.

In addition to the blocked drain above the underpass there is standing water in the siding itself and a former weighing station full of water just to the northeast which may be a contributing factor. It is also possible that a burst buried drain pipe may be contributing to the seepage.

It was not possible during the visit to obtain drawings of the drainage system around the underpass which should be in the architectural drawings currently sought by Hayat project staff. It is recommended that if possible a drainage or municipal engineer carries out an assessment of the drainage associated with the underpass to ensure that there are no additional factors involved or works required. If not, then pumping out and unblocking of the existing drainage systems above and within the underpass would be the only intervention required to solve the standing water and seepage issues currently a root problem in the underpass. Cleaning, refurbishment and lighting of the underpass could then start without fear of destruction by water ingress.

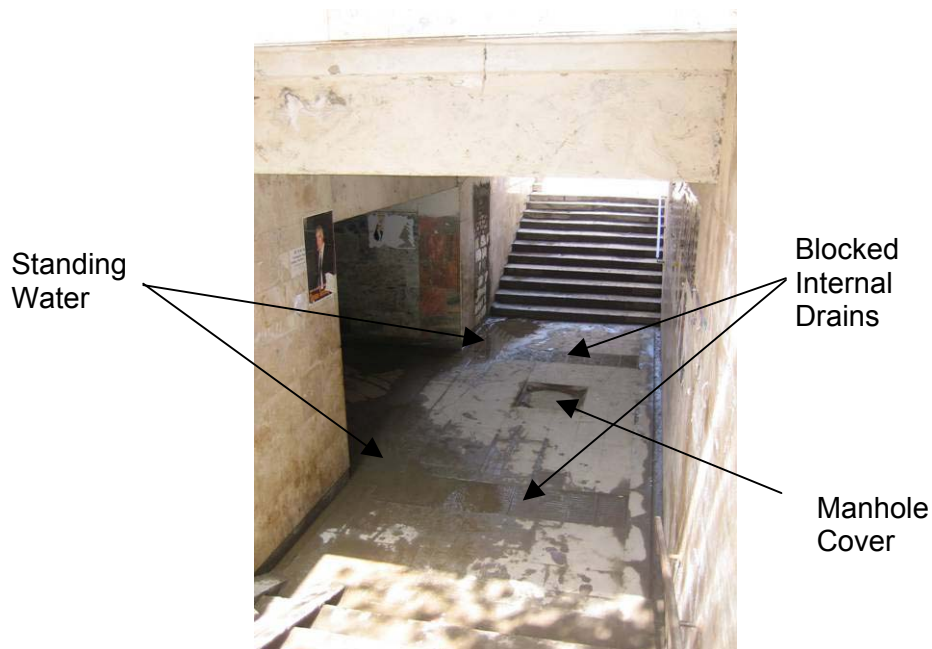
Figure 10 - View of standing water and internal drainage at the north end of the underpass

Figure 10 below shows the internal drains at the northern end of the underpass which are blocked with mud and garbage which are leading to water standing at the mouth of the underpass.

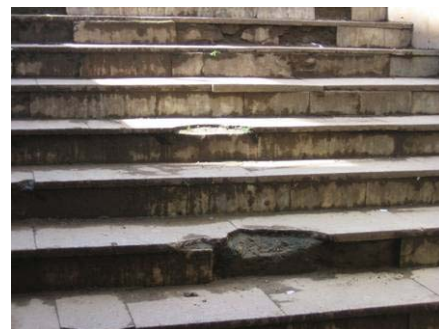
Figure 11 - Broken steps in the underpass

There are several broken steps as illustrated in Figure 11 which present safety hazards to users of the underpass, especially currently given the lack of lighting at night. Broken steps should be replaced to remove this hazard and contribute to the general accessibility and usability of the underpass.

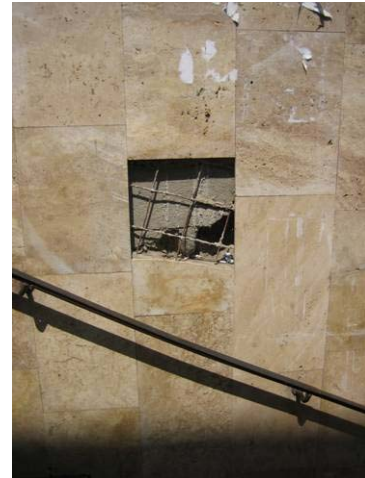
Figure 12 - Broken walls and ceiling facings

Internal walls and ceilings are damaged in several places (such as that shown in figure 12) where marble is missing, concrete has cracked or plaster has been damaged by water ingress, removal of wiring and lighting fixtures or vandalism. As with the drainage it is recommended that a structural engineer carry out an assessment of the underpass to ensure that none of the damage has structurally undermined the construction. Assuming that this is not the case, replacement of broken wall and ceiling parts should be undertaken to raise the quality of the environment in the underpass and with it hopefully the perception of value in the community.

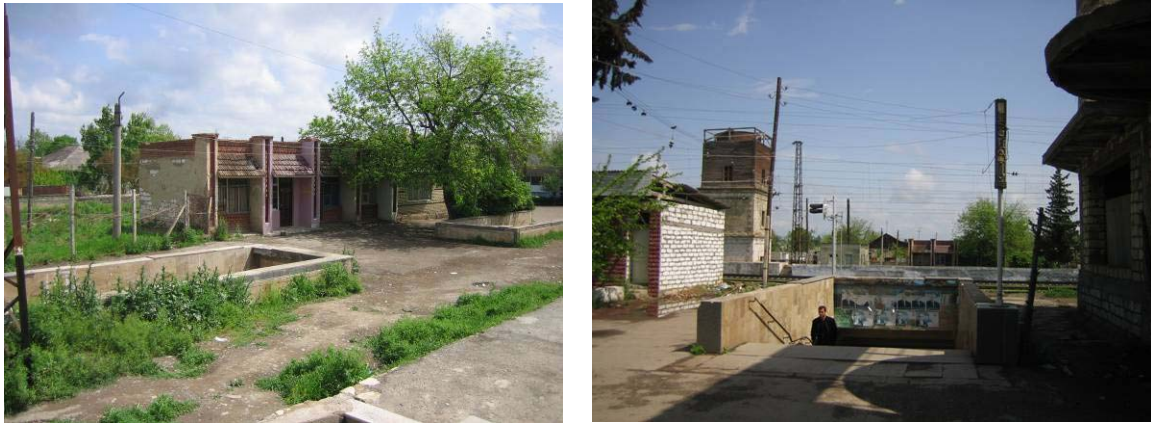
Figure 13 - Northern entrances (left) and Southern entrance (right)

In addition to the improvement of the actual fabric of the underpass, a significant part of the perception of the underpass occurs as the pedestrian approaches it which may be from any of the three accessways (two on the north, one on the south). The short distance from the underpass accessway on the south to the main square is currently under development to the extent that a public wedding building is being built alongside while a small park is to one side. On the northern side the accessways are close to the train station platform but the paths and general area are in poor condition as shown in Figure 13 below left along with the southern entrance on the right:

Improving the approaches to the accessways would improve perceptions of the underpass, make it more welcoming and offer an opportunity for personal involvement from community members not able to do specialist work like drainage or wiring. It would also provide an improved setting for the solar PV panels which will be discussed later in the section. Approaches might be improved by being cleaned up, having paving added, plants, trees etc. Areas which might benefit particularly from this are as shaded in green in the general layout shown in Figure 14 below:

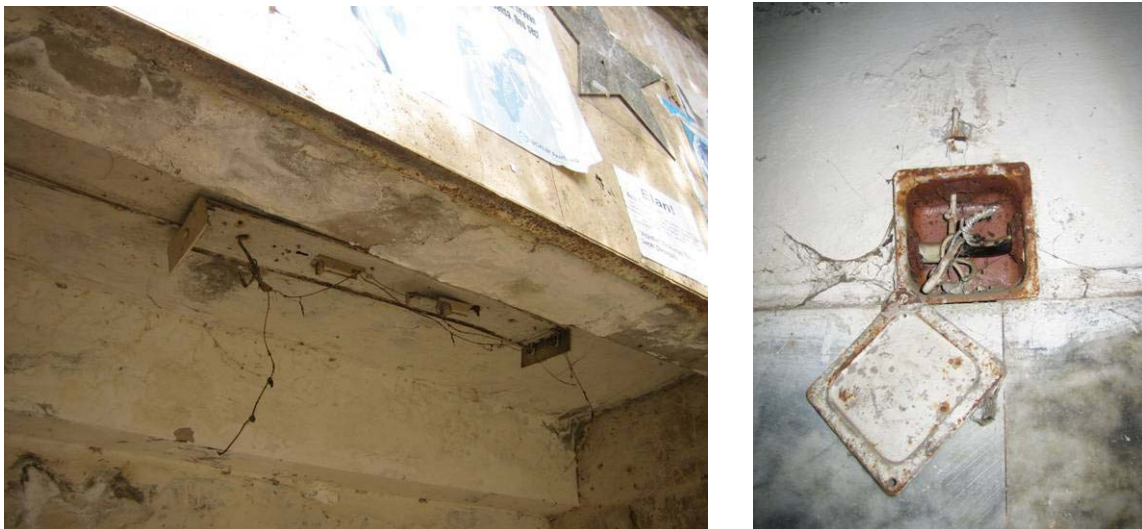
Figure 15 - One of few remaining original light fittings (left) typical wiring junction box (right)

As described previously, lighting in the underpass is the essential energy service affecting the utility and safety of the community using it. There are currently two sets of lighting infrastructure within the underpass neither of which is currently operational. The original soviet-era lighting system is built into the walls using junction boxes and concealed cable conduits while a more recent system of exposed jerry-rigged wiring and bare bulbs was apparently installed after the original system went out of operation. Almost all of the original light fittings which housed fluorescent strip lighting have been removed from the ceilings and the coverings for the wiring junction boxes removed as shown in figure 15 below.

The circumstances behind the breakdown of the soviet-period system, including the removal of the light fittings and the opening of all the junction boxes etc, is not known

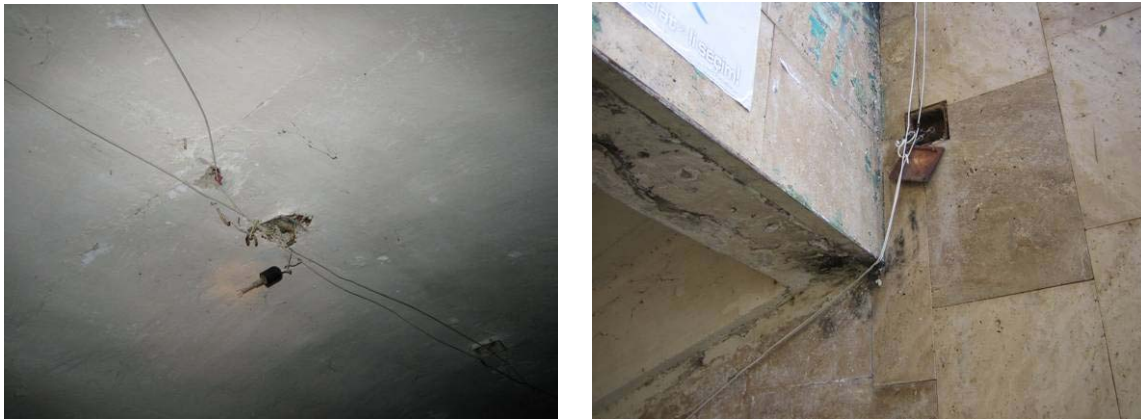
Figure 16 - Broken incandescent lightbulb and recent ceiling wiring (left) and recent wiring entering the underpass past soviet-era junction box (right)

The wiring which was introduced, apparently to provide lighting after the previous system stopped working is as shown in Figure 15 below.

This wiring has obviously been very cheaply and quickly installed and it is not known whether it was carried out by anyone associated with the utility or ministry of transport. The system has gone out of service for unknown reasons although this is not surprising given its poor implementation and lack of co-ordination with any other underpass improvement. It is recommended that the utility electrician establish where the grid connection is and ensure that the fault is not in the supply. It is likely that none of this wiring will be reusable on electrical safety grounds and it will have to be removed and new wiring installed with the new lighting system.

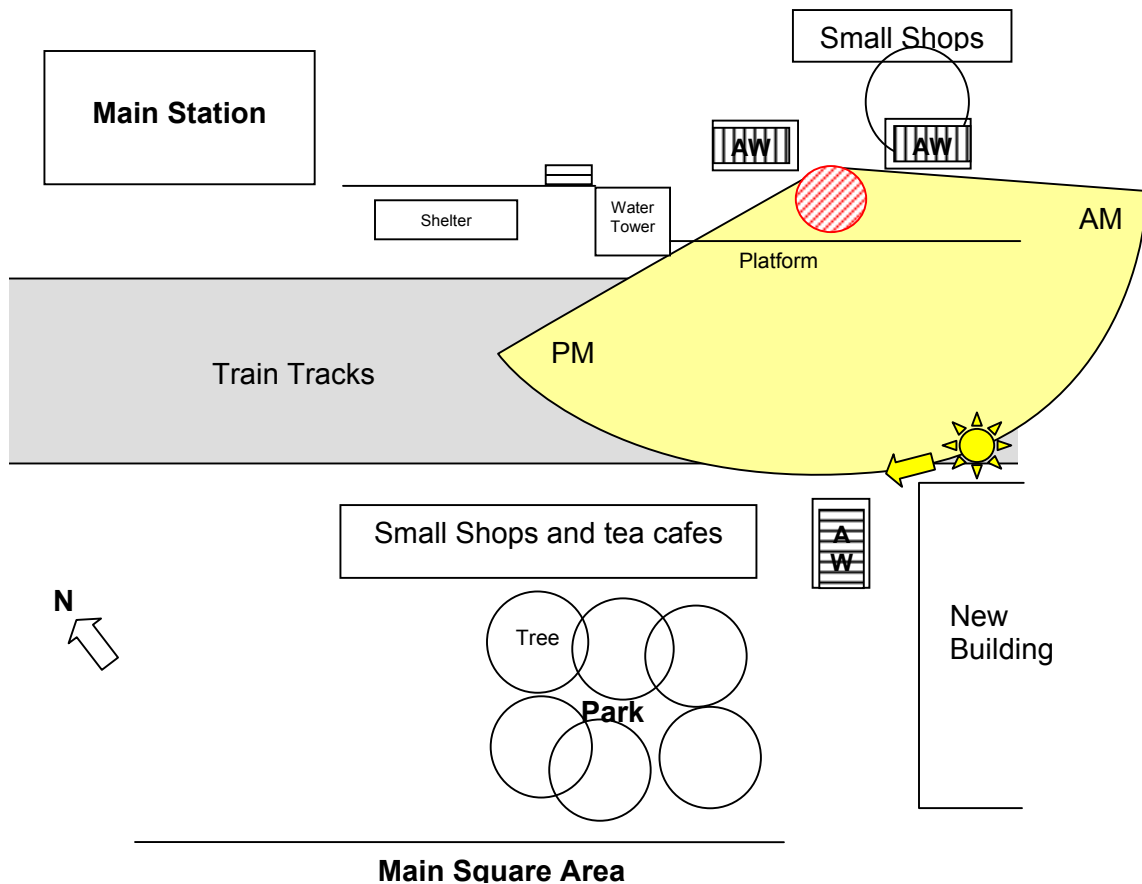
Figure 17 - Proposed location of Solar PV Panels hatched in red on the general layout

In the opinion of the consultant the best location for the panels is likely to be as shown hatched in red in the in Figure 17 below with the sun's path shown in yellow.

The proposed location is not overshadowed to the south due to the open land above the railway lines, is visible to pedestrians from all the accessways into the underpass including the entrance from the main square. The rough land between the two Northern Accessways is also suitable as it is fairly clear of buildings and overhead wiring. Overshadowing by passing trains is possible if the panels are too close to the ground or the platform so they should be stepped back slightly from the platform and raised off the ground on a metal frame up at a height of 3-4m. This also helps avoid vandalism and theft especially if the frames are relatively hard to climb and the panels firmly fixed. It would also make sense to light the area around the bottom of the panels from the same system to both highlight them for passing pedestrians and deny potential thieves the cover of darkness.

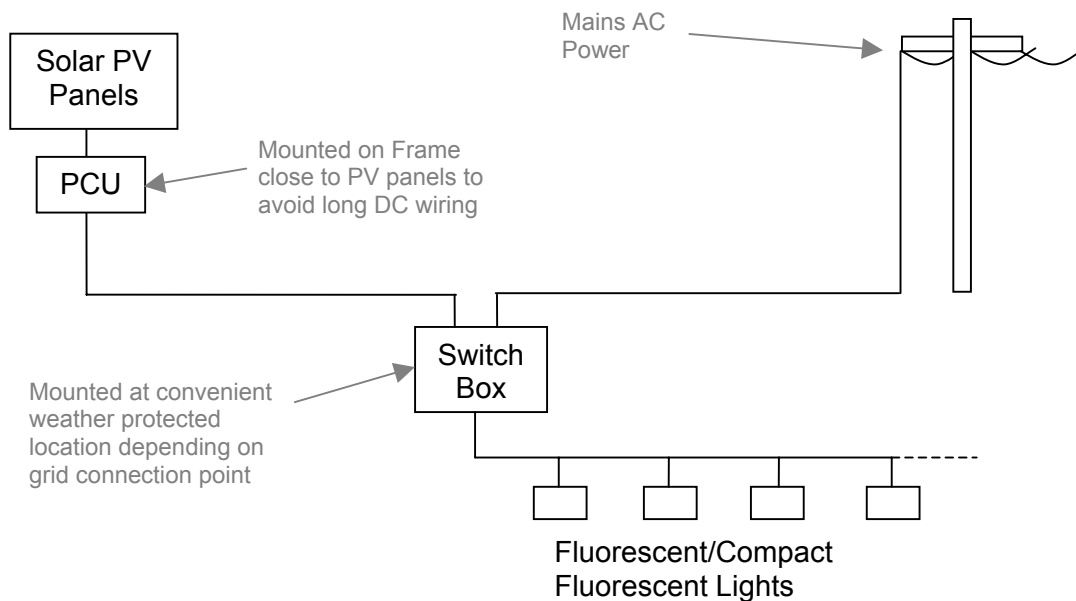
Figure 18 - Wiring Layout proposed for switched minigrid Solar PV system

The wiring routings will have to be agreed with the transport/utility electrician but in general the arrangement should be as shown in Figure 18 below.

The number and power of the lights, corresponding size of the solar PV panels and capacities of the wiring, specification of the switch box etc would be decided during the detail design phase in consultation with suppliers of solar PV systems who would be involved in the tendering process.

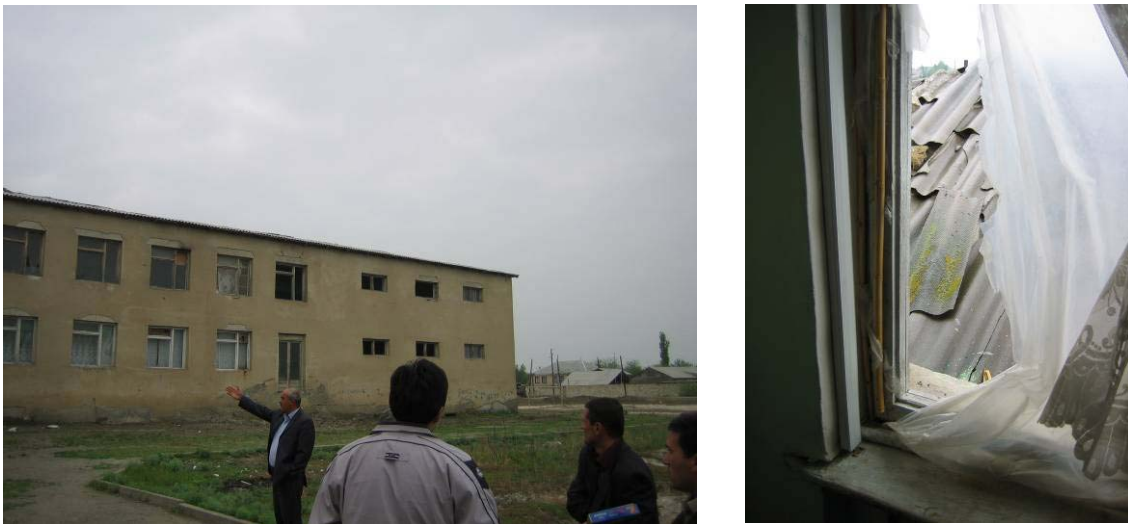
Figure 19 - Exterior of Samadabad School (left) and view from broken window onto roof (right)

The Samadabad school in Yevlakh region was visited on 18/04/06 and the visit report is contained in Appendix 2. The school is in extremely poor condition and it was felt by the consultant that an alternative energy/energy efficiency based project at the school with a value of \$10-12.5K would only have been able to create a relatively small pocket of improvement in the school which requires a more substantial overhaul. Before any other project is undertaken, the school requires replacement of the roof which is in extremely poor condition and of all the windows in the classrooms virtually all of which are broken and warped (Figure 19 right). There are 21 classrooms (63 windows) while several of the corridors lead directly onto the classrooms and should also have windows replaced (another 20-30 windows). It is expected that the AZRIP Programme will bring gas to the school within the next few months but a boiler and central heating system should not be installed before the roof and windows are fixed or this will result in the waste of a large amount of heat energy without significant benefit to the conditions within the school. Additionally the school currently has no running water which is also a priority intervention for the school.

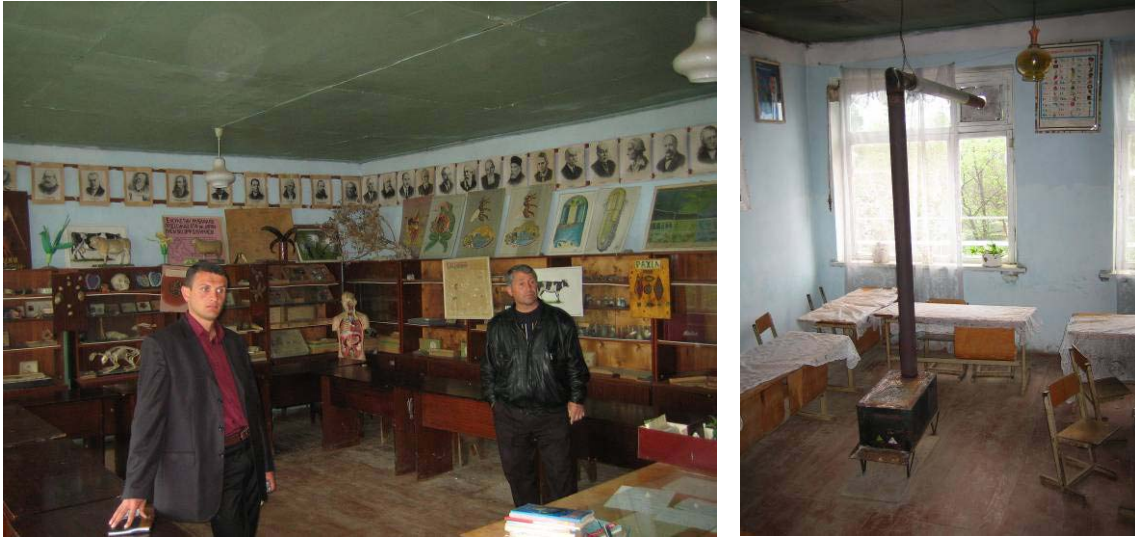
Figure 20 - Classroom in Yahdeli School showing ceiling (left) and wood burning stove (right)

The Yahdeli school in Yevlakh region was visited on 18/04/06 and the visit report is contained in Appendix 2. A follow-up visit to the school was also undertaken on the 19/04/06 to discuss potential projects at the school. General fabric of the school is in fairly good condition benefiting from intelligent environmental layout with a wood of tall trees to the north blocking cold winds and all the classrooms on the southern exposure of the building to benefit from maximum passive solar gain in the winter. The roof has recently been replaced as part of a BTC funded project and is in very good condition. The main problems at the school are the ceilings which were damaged by rain prior to the roof replacement but not replaced themselves which are very thin, warped and extremely poor insulators, and the windows which are in poor condition showing large gaps and warping. Currently, inefficient woodburning stoves are used in all the classrooms to provide heat in the winter.

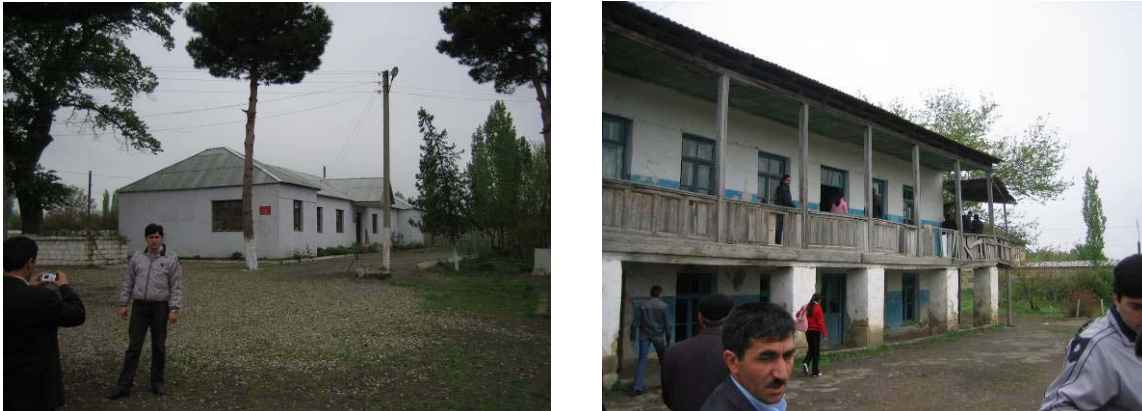
Figure 21 - Gimli Boluslu School newest building (left) and oldest building (right)

The Gimli Boluslu School in Goranboy region was visited on 19/04/06 and consists of three different buildings dated 1924, 1967 and 200X. The newest building shown on the left in Figure 21 was built as part of a BTC financed project and houses the youngest children. The new building is fundamentally sound but lacking in any insulation or energy efficiency measures and in that respect is similar to the Qara Jali Clinic in Ujar. A similar project to that described in chapter 2 could therefore be proposed at Gimli Boluslu. The two other buildings are in poorer condition, similar to the Yahdeli School and would benefit hugely from similar projects in replacement of windows, ceilings/ceiling insulation and improved stoves. As in Yahdeli, the Gimli Boluslu community are expecting gas in the near future and if that is to happen then again a project to implement an efficient gas boiler system or perhaps a flexible fuel boiler using both biomass or gas could be developed.

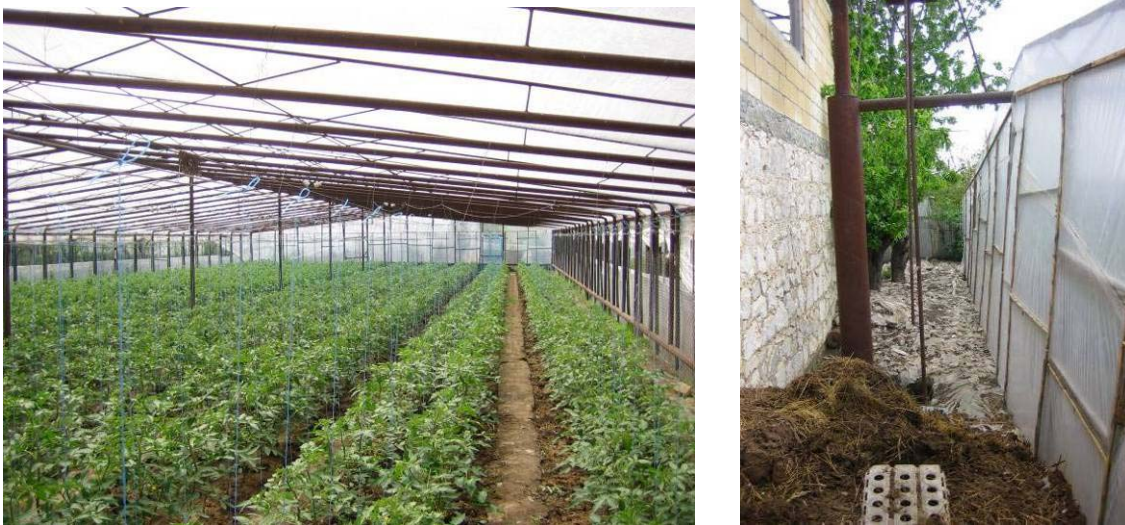
Figure 22 - Greenhouse in Dallar Jayad (left) and oil burning heating system (right)

The initial feasibility of a project using biomass heating of greenhouses was considered in the context of Shamkir which was a region selected by Hayat for its likely match to the project criteria. It was found that there may very well be a high demand and use for a project using agricultural waste for greenhouse heating for a number of reasons. There are large amounts of waste from agriculture in the region mainly in sunflower, potato and corn. Currently the remains of these crops are left or burned in the fields. The cultivation of tomatoes and cucumbers in greenhouses is already a significant industry in Dallar Jayad with many families typically owning one or two greenhouses providing an income from export of tomatoes through family members to Russia while cucumbers are mainly sold in the domestic market.

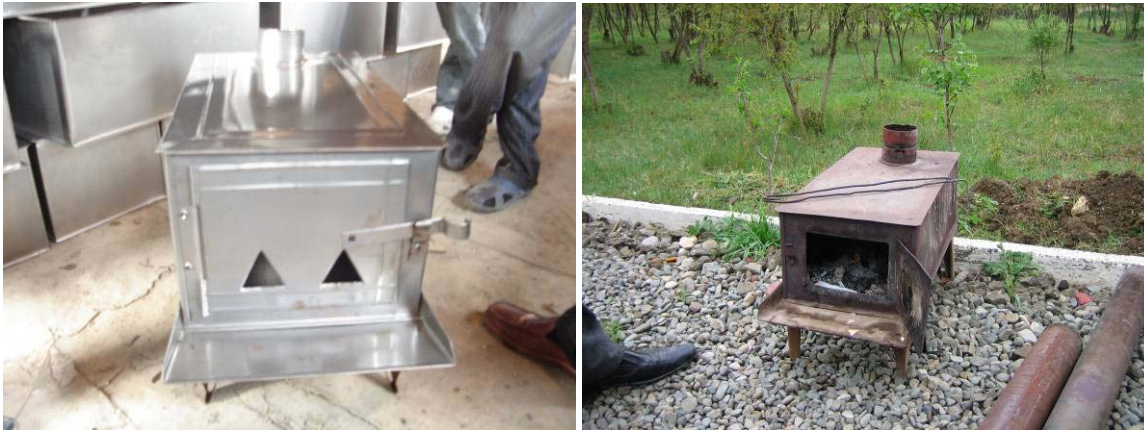
Figure 23 – A brand new woodburning stove (left) and the same type of stove after use at Gimli Boluslu School (right)

Woodburning stoves of the type shown in Figure 23 were seen in every school visited during the visit to Azerbaijan (see also Figure 20, right) and a remarkable consistency can be seen in their design across the region. These stoves are of lightweight steel construction, are relatively inefficient, last a maximum of two winters according to school principals and often result in smoke entering the room depending on the chimney output and the wind direction. However they are extremely cheap, retailing at only around \$10 each. Typical failure modes are holes appearing in body of the stove and warping due to heat causing the folded seams to split making the stove unusable. Combustion design issues include the lack of primary air feeding up through fire, the small surface area of heat exchanger (flue) and the lack of insulation to keep burn temperatures high.

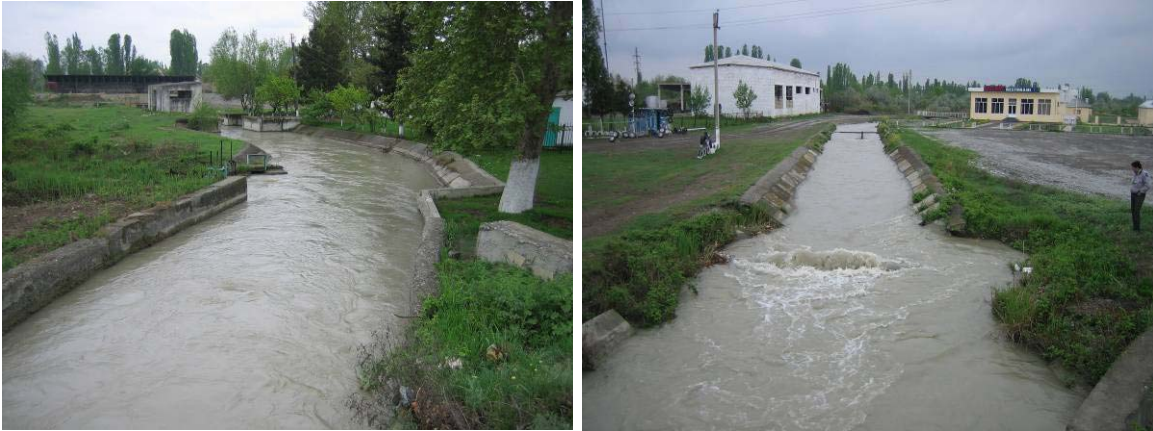
Figure 24 - Images downstream (left) and upstream (right) of the Ujar canal with micro-hydro potential

A strongly flowing canal in Ujar as shown in Figure 24 was pointed out by the Hayat Project staff as having potential for micro-hydro. Although having low head height, the flow rate, estimated at around 11-12m³/sec, does make it feasible for use in a ***run-of-river*** type system. Local bystanders asserted that the canal was of consistent height and flow all year due presumably due to level control at the inlet further upstream.
